**December 4, 2024**  
**SESI Job No.: T24-343**  
**SESI Asbestos Business**  
**No.: ZA-0000092**  
**EPA TSCA FLORIDA**  
**LBP FIRM: LBP-15608-3**

**SUBJECT:** Asbestos NESHAPS Demolition Survey & LBP Testing Report for the 2 former school structures located at 176 NW Crane Avenue in Madison, Florida

**MADISON HEALTH & WELLNESS CENTER**

176 NW CRANE AVENUE  
 MADISON, FLORIDA 32340

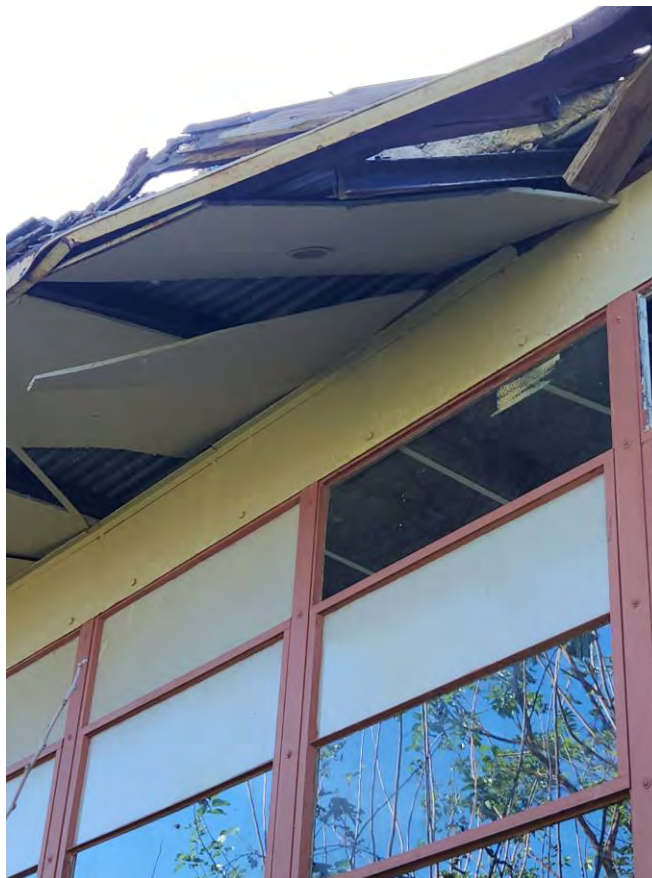
- Cementitious transite soffits on the north building and walkway soffits

- The cementitious transite soffits on the walkway roofs contained 15% chrysotile asbestos. (approximately 928sf)
- The cementitious transite soffits on the North Building roof contained 15% chrysotile asbestos. (approximately 820sf)
- The black transite laboratory sinks/table-tops in Room 9 and the Storage Room between Rooms 3 & 5 contained 15% chrysotile asbestos. (approximately 28sf of table-tops)

The identified Friable ACM (TSI in Old Boiler Room), transite soffits on the North Building & Walkways and transite sinks/table-tops should be properly abated by a Florida Licensed Abatement Contractor with certified supervisor & workers. All ACM debris must be properly marked, wrapped and disposed of as asbestos waste. Once abated, the remaining ACM can be demolished with the structures as part of a wet demolition with an AHERA Supervisor onsite during demolition activities, if desired. **However, it is a direct violation of the Asbestos NESHAPS to recycle building materials if ACM is left. Therefore, SES recommends that all ACM be abated from the structures prior to demolition.**

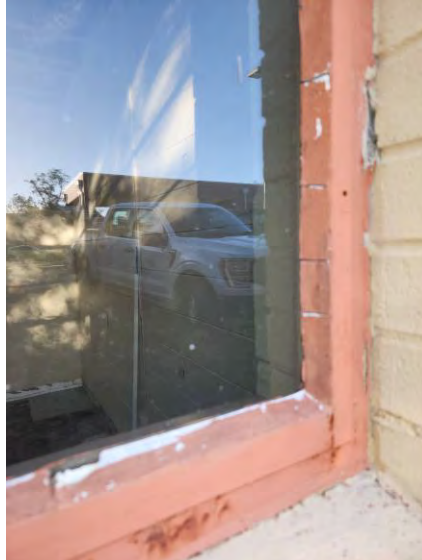
- Black laboratory sinks and countertops in Room 9 & Storage Room between Rooms 3 & 5

- Exterior window caulking on both buildings

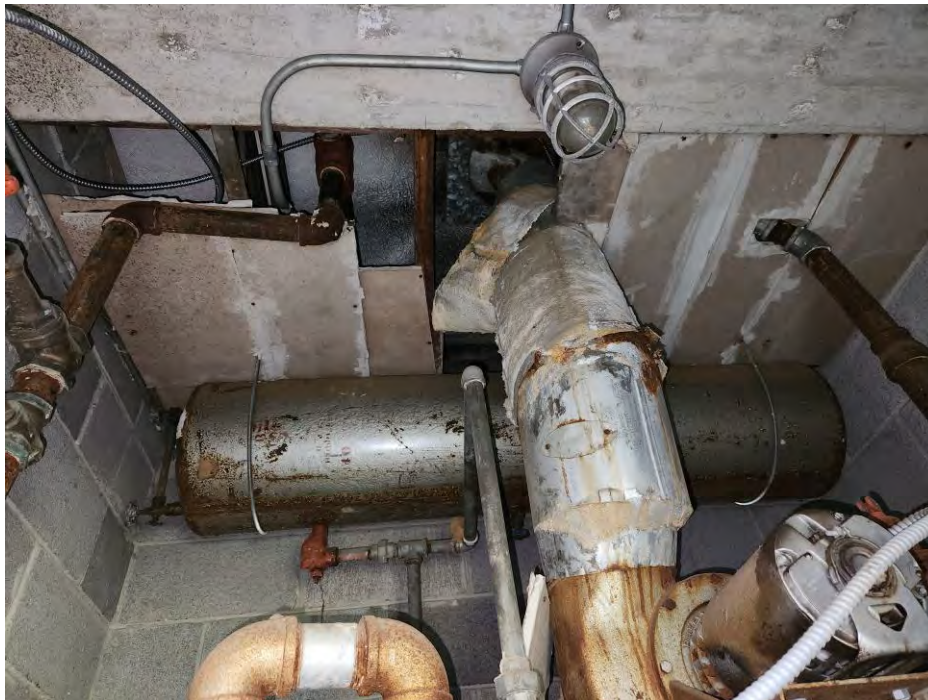
- 9” and 12” VAT with black tile mastic in the Auditorium, Offices 2A, 2B, 3, 5, Storage Rm, 6 & 8
- Exposed black tile mastic on the slabs in Rooms 1, 1A, 7 & 9
- Friable white vibration dampers in the ceilings of the Auditorium & Room 2A
- Friable pipe mud & insulation (TSI/wrap) on piping & debris in the Old Boiler Room

- Friable white cloth vibration dampers in the ceilings of the Auditorium and Room 2A contained 70% chrysotile asbestos. (approximately 10sf)
- Friable white cloth wrap and insulation (TSI) in the Old Boiler Room Exhaust Line contained 25% - 65% chrysotile asbestos along with a mudded elbow (TSI) that contained 20% chrysotile asbestos. SESI noted visible debris on equipment in the room and on the floor. (approximately 3 LF)

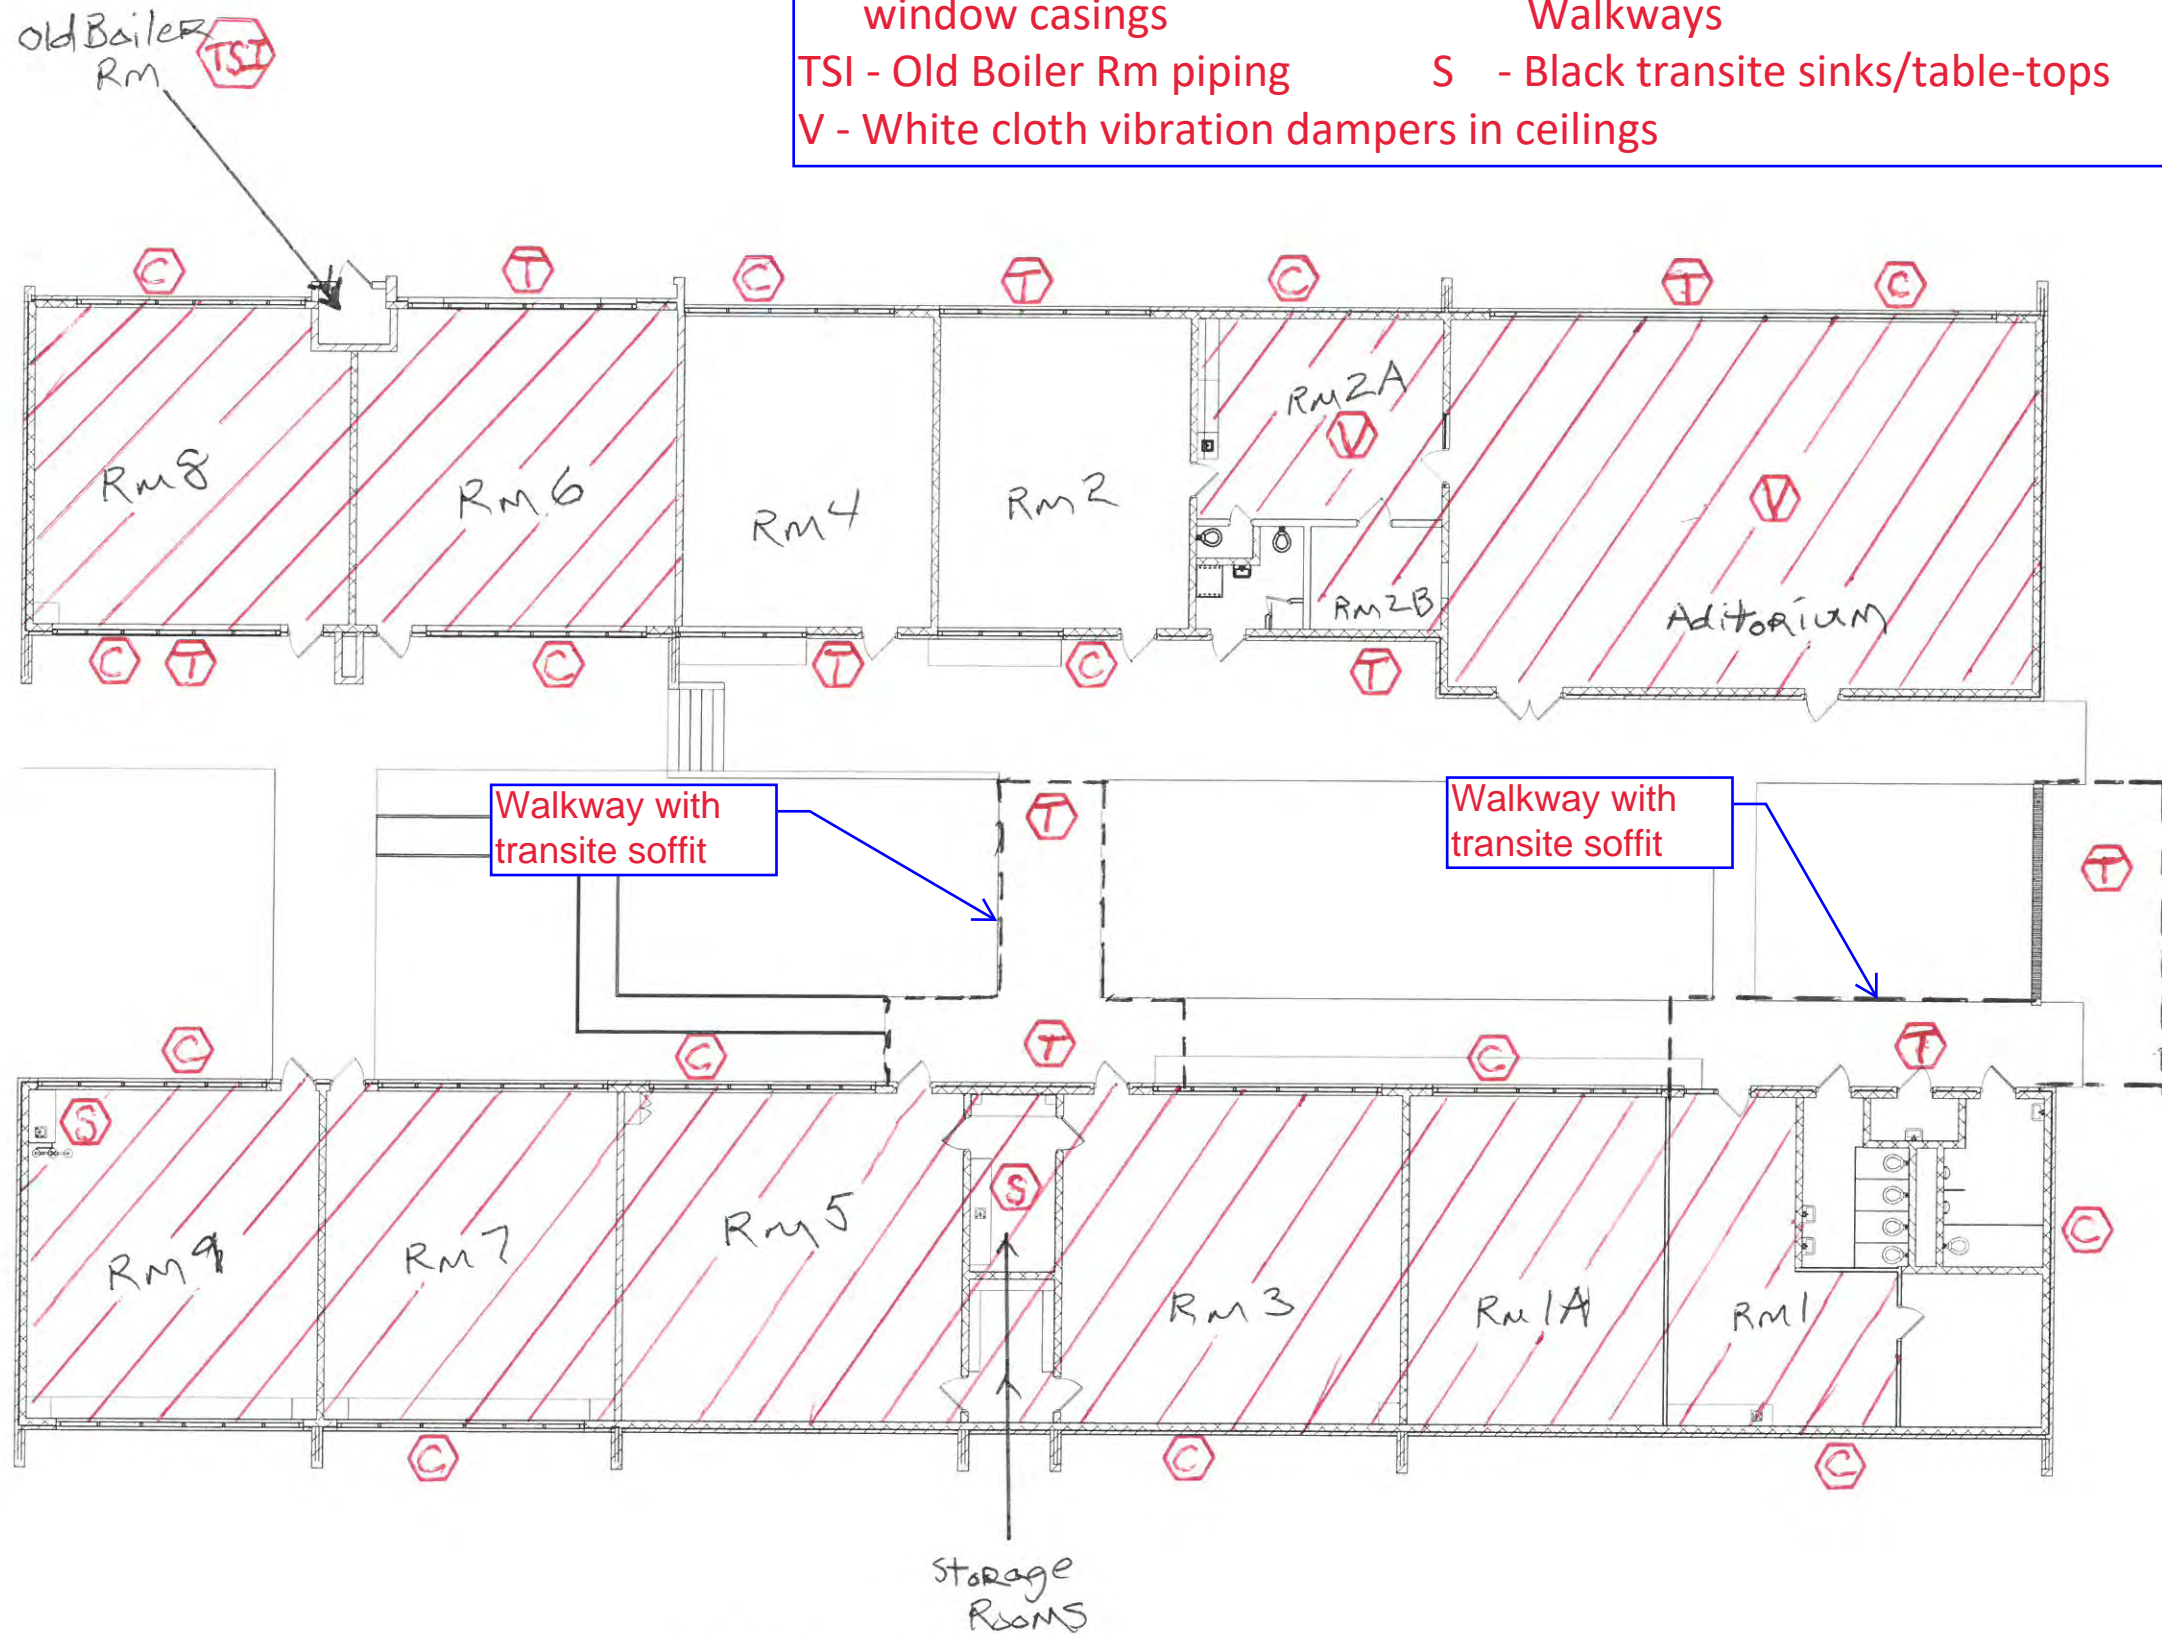
SHEET TITLE  
 EXISTING FLOOR PLAN  
**A1.1** of

-- IDENTIFIED ACM --  
 C - Caulking on exterior window casings  
 TSI - Old Boiler Rm piping  
 V - White cloth vibration dampers in ceilings  
 /// - 9" VAT, 12" VAT & exposed black mastic  
 T - Transite soffits on North Building & Walkways  
 S - Black transite sinks/table-tops
