Mini Scope of Work

This is a USDA Track Two: Impact Grant request budgeted at \$2,452,927 over a twelve month (12) month period beginning, January 1, 2025, through December 31, 2025 construction project to remodel a single story block building. The scope of work (SOW) involves remodeling a building on the southwest side of the hospital campus. It was built in the 1950's and although structurally sound, needs repairs and updates.

Proposed Facility

Madison Health & Wellness Center Proposed Facility

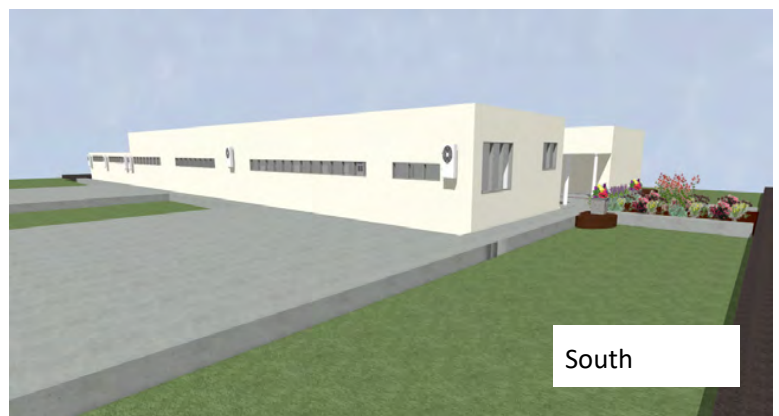
This building will mimic the look and feel of the hospital. Faux stone dresses up the the building exterior with light-colored walls matching the hospital building. The trim and interior colors are gray, blue, black and white to match the the hospital brick.

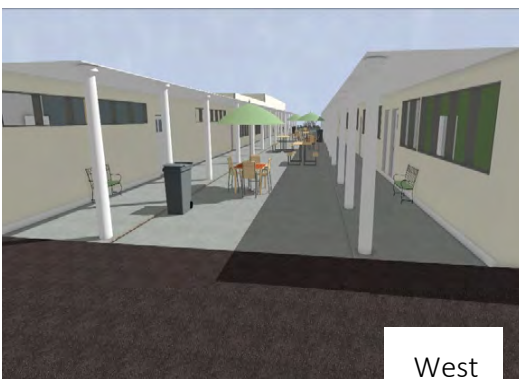
In order to resolve liability issues with the uncovered atrium consultants have recommended covering the middle section during the roof renovation. Originally three peak design would mimic the peak on the front of the hospital and utilizes truss and metal roofing over the existing roof to give it a much needed face-lift while simultaneously fixing roofing issues and providing additional insulation. Storm damage requires new roof and replacement of most if not all insulation. Using state of the art PVC ceiling, with lights and ceiling fans the area becomes a multipurpose area for overflow lobby and employee and patient services with benches, picnic tables, and umbrellas as well as potential closure in the future to add an additional 7,000 square feet as usable clinical space.

The original intent for roof over was to follow the hospital design with all three section having a peak that mimics the front of the hospital as far as the shape, the tin, and the arched windows. With storm damages and addition deterioration because of the delays, the architects are recommending a different roof line and designs are in development. The exterior wall is made to match the existing building exterior rather than hospital brick. Additional details are provided in a room-by-room description in the remodeling section on the following pages final design is dependent on General Contractor and Architect recommendations.

- **Roof Renovations** include a truss over existing roofing system to upgrade from a flat roof to a gable roof on both existing wings and add a covering to the existing atrium to tie it into both wings in order to decrease slip and fall and provide overflow for patients, employees, and community outreach.

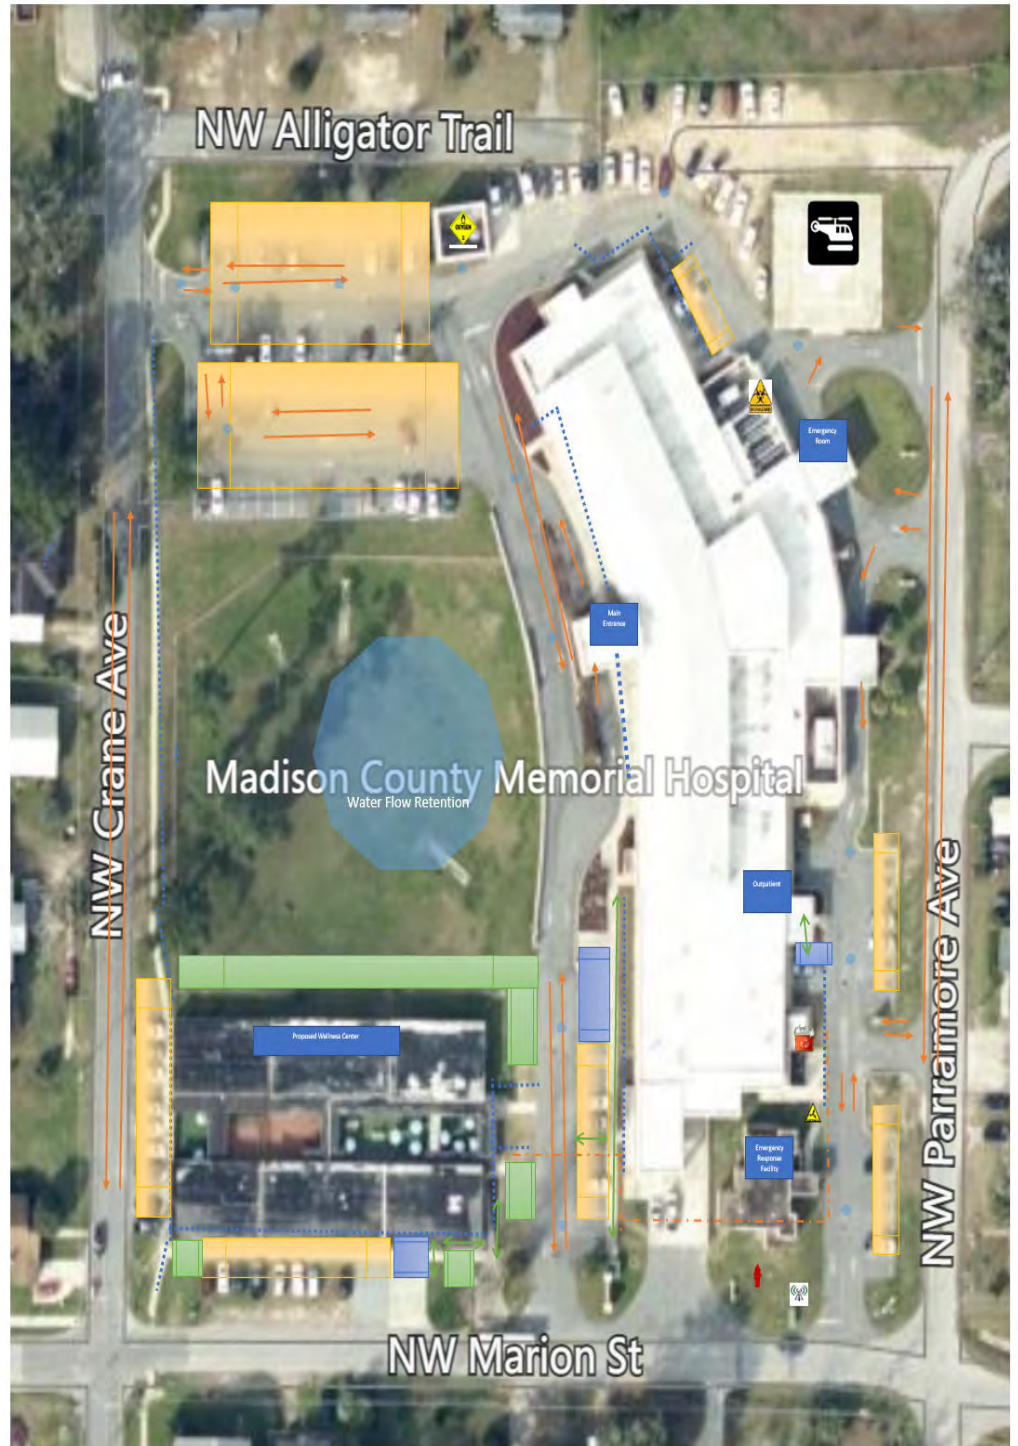
Emergency Response Facility and Wellness Center Site Plan

Hospital Campus Layout & Existing Infrastructure (See site plan for additional details)
